## OHIO CITY DEVELOPS MANHOLE

# Rehabilitation Program

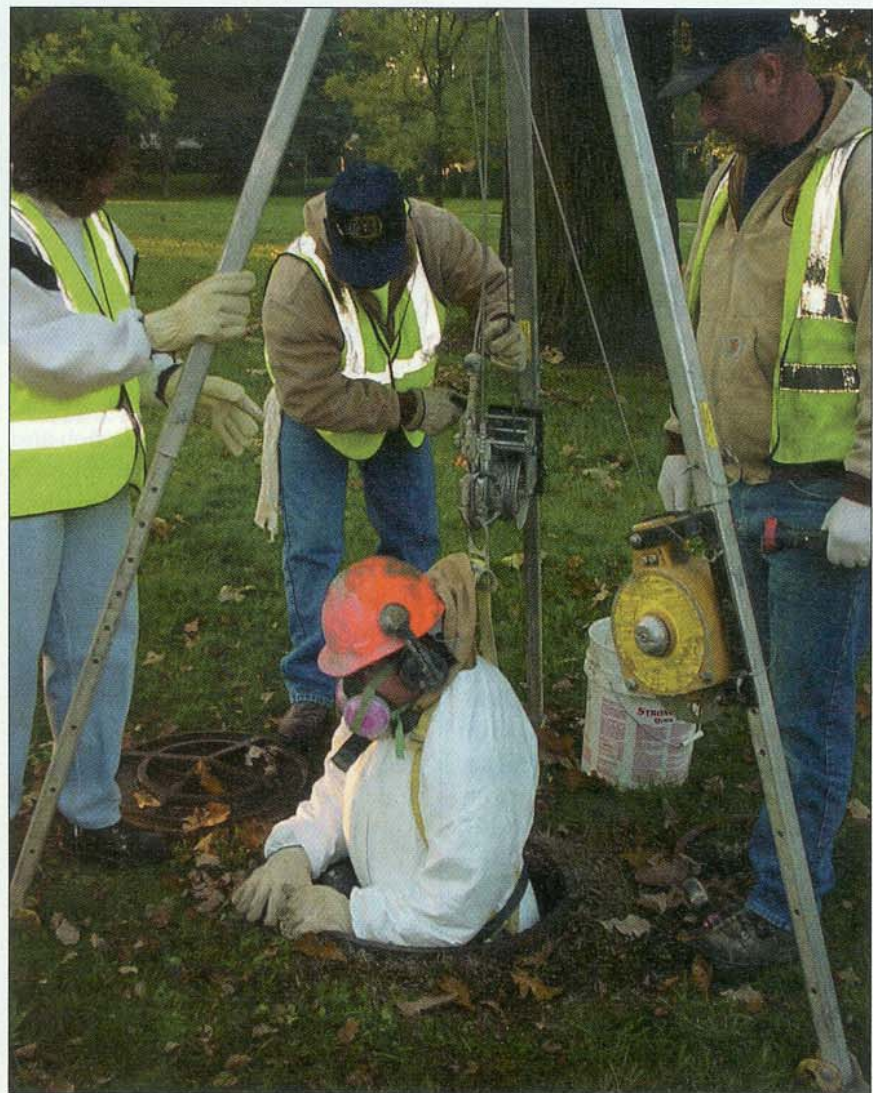
Crew members wear safety equipment to protect themselves from the hazards of confined spaces.

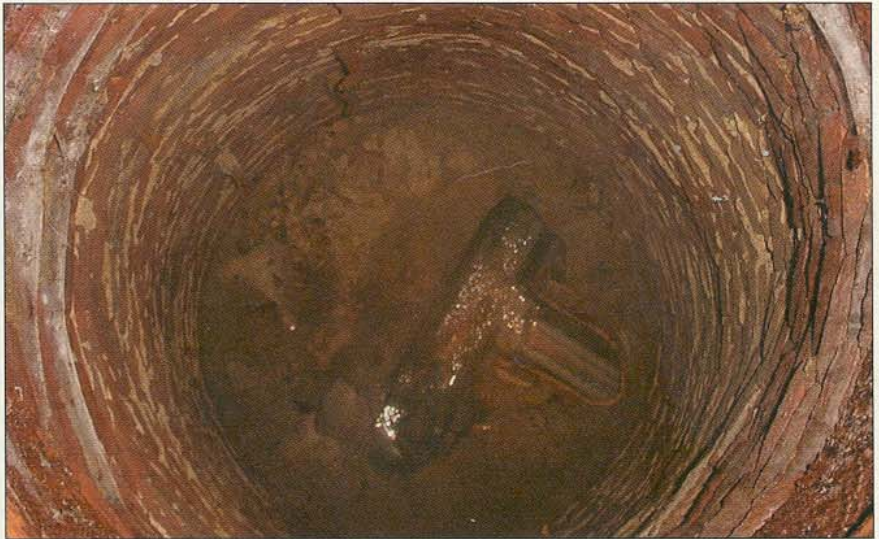
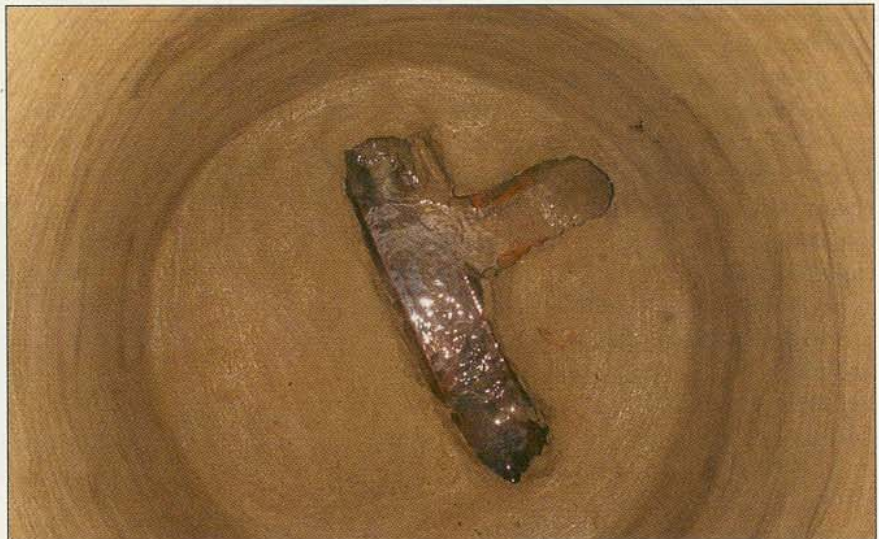
Top: A corroded brick manhole before the cementitious rehabilitation. Bottom: The manhole after rehabilitation with the Strong-Seal® MS-2A liner material. Because many of the manholes were located in difficult-to-access rear easements, the application equipment had to be able to pump materials long distances.

search of available equipment and technology, including attendance at trade and technical shows, private and association educational sessions, demonstrations, and visits to job sites. Ultimately, spray-applied, fiber-reinforced cementitious liner material was chosen as the best combination of cost-effectiveness, ease of application, and long service life. One of the primary requirements of the application equipment was the ability to pump materials long distances as the majority of the manholes were in rear easements that were difficult to access. After the bid process, The Strong Company's (Pine Bluff, Arkansas) Strong-Seal® MS-2A liner material and Strong Manufacturing's application equipment was accepted as the lowest and best bid on both the materials and equipment.
